Special Situations Call for Extraordinary Measures

Empirical Data for Validation of Reactor Design

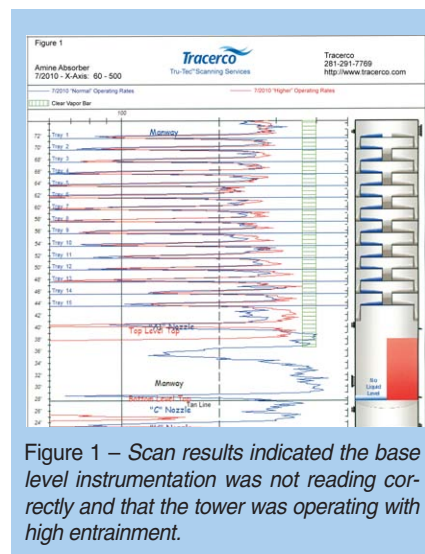
Figure 1 – Scan results indicated the base level instrumentation was not reading correctly and that the tower was operating with high entrainment.

perform TRU-SCANS® to determine if flooding was occurring and to determine if any other problem was present. Due to the extreme wall thickness a source with higher energy was selected in combination with an ultrasensitive detector, built specifically and exclusively by Tracerco for challenging projects. Two scans were performed at different operating conditions. (Figure 1) The first scan (blue scanline) indicated all the trays (1 – 15) were in place, holding aerated material and were operating with what appeared to be heavy entrainment. Trays 1 – 9 indicated more froth/aeration density (higher degree of entrainment) between the trays compared to Trays 10 – 15. Furthermore, there was no indication of a bottoms level identified in the base of the tower, while control room instrumentation indicated a 50% base liquid level.

A second scan was performed (red scanline) at reduced vapor rates. Under these conditions there was a slight reduction in froth height on the trays and a decrease in entrainment between the tray decks. However, a base liquid level was detected approximately 14 – 16 inches below the top level tap, at a level of 70% (control room instrument indicated 100% level).

While the scans confirmed the tower was operating with high entrainment which could be the cause of the increased ΔP , a more significant finding was the results that indicated the base level instrumentation was not reading correctly.

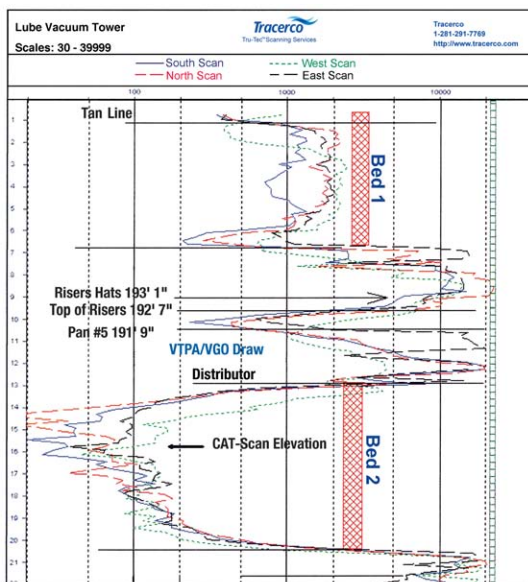
Figure 2 – Tru-Grid™ Scan data indicated that both beds were in place with characteristics of severe liquid maldistribution.

techniques including a Tracerco Tru-Grid™ Scan and Tru-CAT™ Scan were employed. The Tru-Grid™ Scan results indicated that the two beds were in place with characteristics of severe liquid mal-distribution (Figure 2). The top bed appeared to exhibit excessive liquid on the south side accompanied by liquid deficiency on the west side of the tower. Bed 2 appeared to be holding an excessive amount of liquid in the top section of packing and exhibited severe liquid mal-distribution. The liquid mal-distribution appeared to become less severe lower in the bed below the section of packing with excessive liquid accumulation. A close look at the collected data for the chimney tray between the beds indicated that liquid was overflowing the risers on the south and east scans. Liquid appeared to be level with the top of the risers on the north scan and

With the draw rate increased to prevent the collector from overflowing, a Tru-CAT™ Scan was performed at the elevation noted in Figure 2 in order to view in greater detail the pattern of liquid maldistribution.

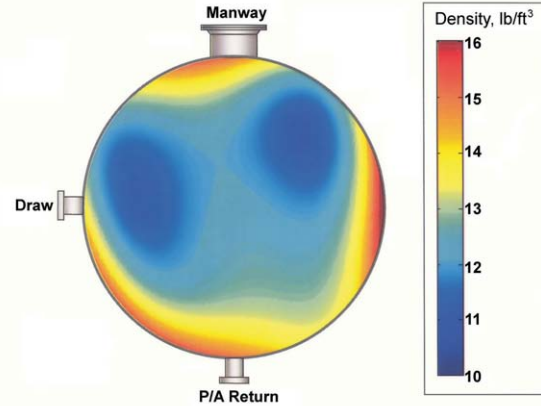
Figure 3 – Tru-CAT™ Scan color contour plot results illustrate where two dry spots were identified in a lube vacuum tower.

The data in Figure 3 represents the Tru-CAT™ Scan results performed on Bed 2 of packing located below the VGO Draw. Two relative dry spots were identified – one in the northeast quadrant and the second on the west side of the tower.

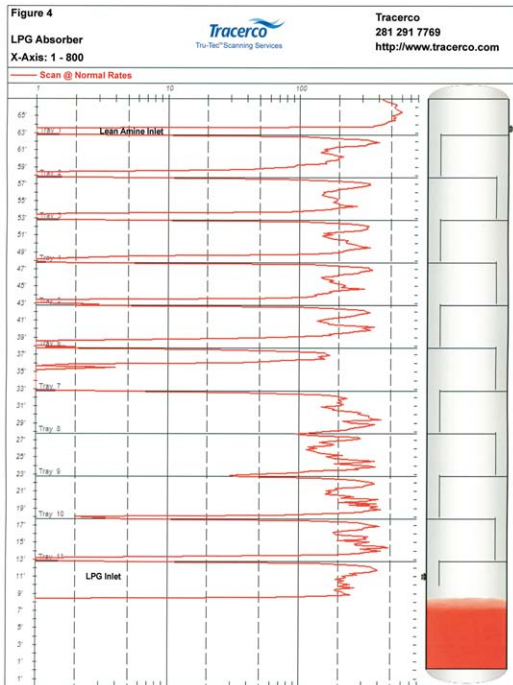
Figure 4 – Illustrates a scan plot of a trayed extraction tower where amine is the heavy liquid phase and LPG is the light liquid phase. A build-up of the heavy phase on Tray 7 showed a liquid restriction where the amine had trouble flowing past Tray 7.

Figure 4 shows a liquid-liquid absorber tower with trays where amine is the heavy liquid phase and LPG is the light liquid phase. This absorber was designed for the trays to hold a level of amine (heavy phase) on the trays and for the LPG (light phase) to bubble up through the amine. On the top trays of this absorber (Trays 1 – 6) there was a dense mass sitting on

the tray decks. Trays 1 – 6 were holding approximately 10 inches (250 mm) of amine. The remainder of the tray spacing was filled with light density phase LPG.

scan profile at Tray 7. Tray 7 has a level of dense phase liquid measuring approximately 38 inches (965 mm), much higher than the trays above. In addition Trays 8, 9, and 10 did not appear to have any appreciable level of dense phase liquid. The scan results showed that the amine or heavy phase liquid cannot flow past Tray 7 most likely due to a restriction in the downcomer from Tray 7. Trays 8 – 10 actually were “starved” of amine so only the light phase liquid LPG was seen on these trays. The customer is now aware of the type of operating bottleneck they have and can formulate an action plan to remedy the situation.

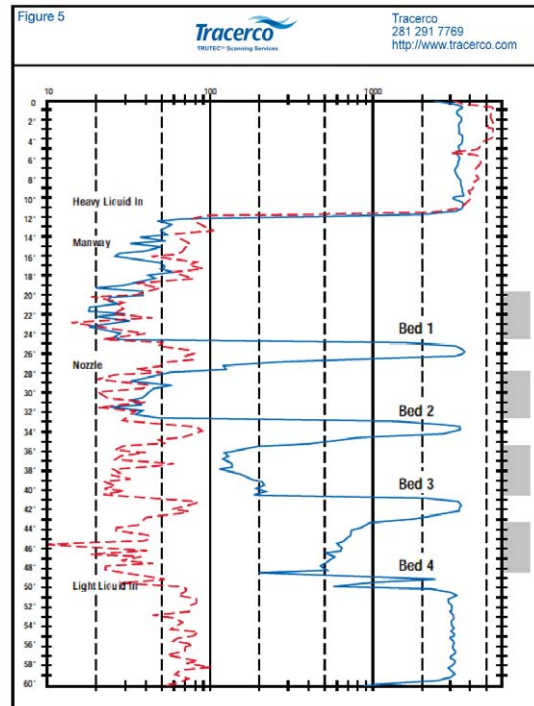
Figure 5 – An illustration showing the scan results from an extraction tower with packed beds. The blue-solid scanline illustrates scan results of the tower with operating problems. The red-dashed scanline indicates the process density being uniform throughout the tower.

Figure 5 shows the scan results from an extraction tower with packed beds. If the two liquid phases were well mixed then the scan profile would be nearly a straight line due to the process density being uniform throughout the

tower. The red-dashed scanline curve in Figure 5 shows this. The blue-solid scanline shows what the extractor would look like when it had operating problems. First, pockets of lower density material were noticeable below each bed, showing that the light liquid phase was not able to flow through the packed beds. Second, Beds 3 and 4 were much lighter in density than Beds 1 and 2. Thus the tower was not well mixed but holding the light liquid phase in the bottom and keeping the heavy liquid phase in the top. This situation was due to the bottom of each bed of packing having a layer of fouling. The scan results showing good mixing were obtained after the extractor tower had been cleaned and returned to service (red-dashed scanline).

Normally it would be very difficult to see where the beds are located from a scan when the extractor was in good operating condition due to all the liquid. However when the operation was bad, the pockets of light liquid trapped under each bed in the scan clearly identified where the beds were. It is ironic but a scan of a well operating liquid-liquid extractor usually reveals less information than a scan of an extractor with problems.

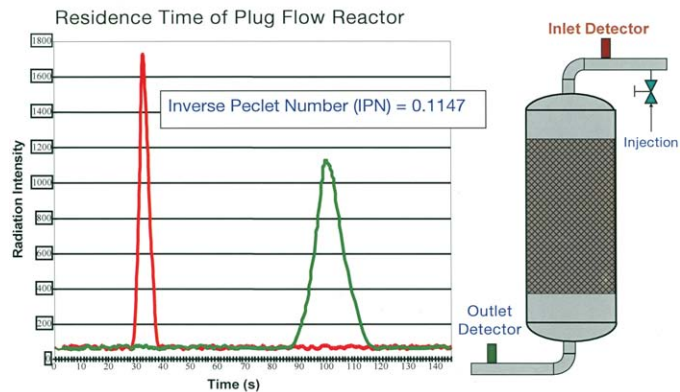
Figure 6 – Illustration of a reactor that is supposed to operate in some regime that is near plug flow. Detector placement on the inlet and one on the outlet will produce responses similar to the above illustration.

If the reactor is supposed to operate in some regime that is near plug flow, then a detector on the inlet and one on the outlet will produce responses similar to those shown in Figure 6. Using the Method of Moments analysis, the Mean Residence Time (MRT) and the Inverse Peclet Number can be calculated.

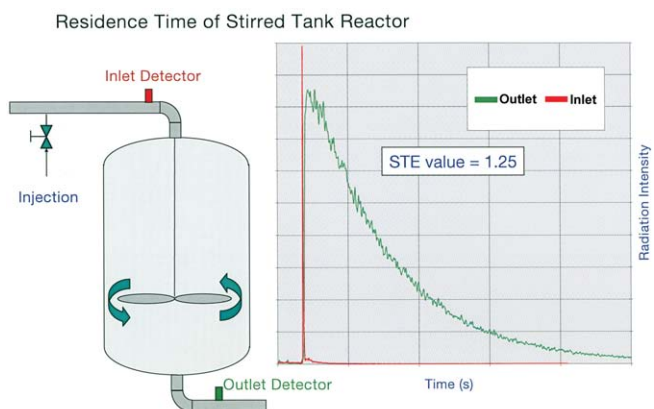
Figure 7 – Response data from a reactor operating in a reasonably well mixed regime with an inlet and outlet detector placement.

If the reactor is supposed to be operated in a reasonably well mixed regime, then an inlet and an outlet detector will produce responses similar to those shown in Figure 7 and the Method of Moments analysis can be used to calculate the MRT and the Stirred Tank Equivalent (STE).

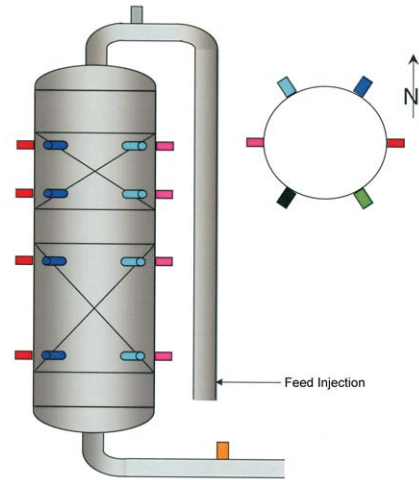
Figure 8 – Four rings of six detectors positioned at elevations show to produce results illustrated in Figures 9 and 10.

fixed catalyst beds. Upon startup, maldistribution was suspected to be the cause of lower than expected conversion. Four rings of six detectors were positioned at the elevations shown in Figure 8.

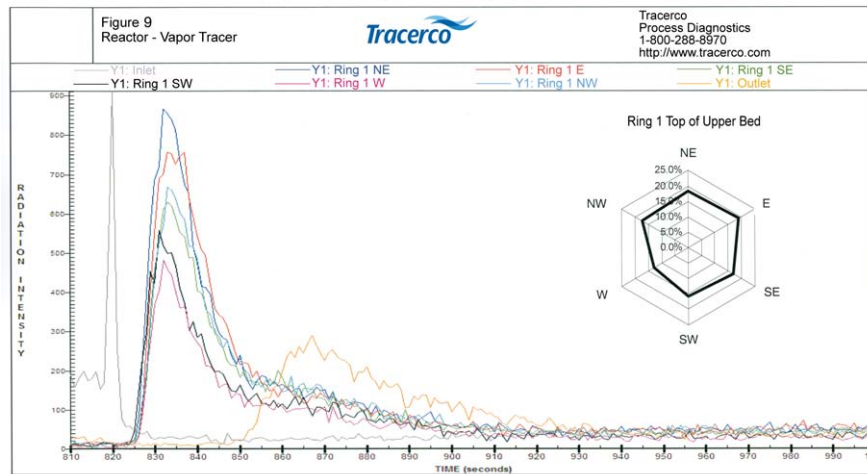
Top Ring of Upper Bed

Figure 9 – The first set of results using the Method of Moments analysis indicated serious maldistribution was present.

The first set of results (Figure 9) show the responses of the detectors in the top ring of the upper bed. It is obvious that the responses are not all of the same height or width. Using the Method of Moments analysis, the areas under each response curve were calculated. The areas under all six responses were summed and then each

The radar plot in Figure 9 shows that almost 20 percent of the flow was measured near each of the NE and E detectors, about 17 percent at the NW and SE detectors, and 11 and 8 percent at the SW and W detectors respectively. Since each detector should have seen 16.7 percent, a total of 40 percent to the NE and E and only 20 percent to the SW and W, indicated serious maldistribution was present.

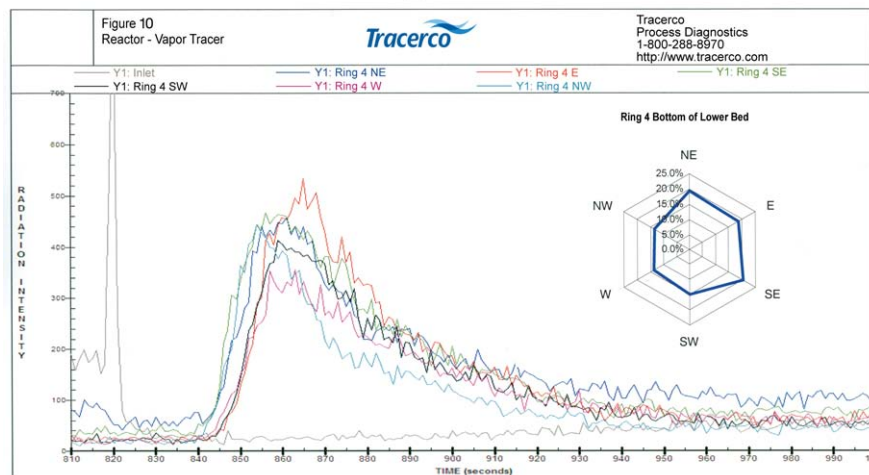
Bottom Ring of Lower Bed

Figure 10 – Results of the ring of detectors at the bottom of the lower bed indicated there was still a 58 - 42% flow bias to the east side of the reactor.

The second graph (Figure 10) shows the results of the ring of detectors at the bottom of the lower bed. The detector responses were more similar to each other, but there was still a 58 to 42 percent flow bias to the east side of the reactor. The Mean Residence Time (MRT) was measured at 36.8 seconds from the upper bed top ring to the lower bed bottom ring and the overall MRT was 53.4 seconds.

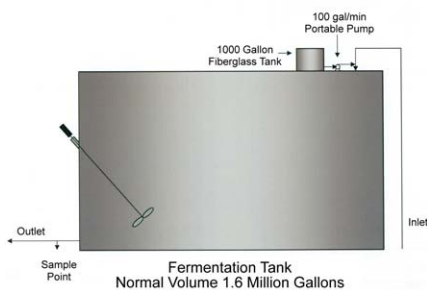
Figure 11 – A North American plant requested Tracerco to determine the Mean Residence Time (MRT) of fluid through one of their fermentation tanks. One of the primary objectives was to determine if short circuiting of the feed was occurring.

A North American plant that converts corn into ethanol for blending with gasoline wanted to determine the Mean Residence Time (MRT) of the fluid through one of their fermentation tanks. The tank was 100 ft. (30.5 m) in diameter and had a liquid depth of about 28 ft. (8.5 m), holding 1.6 million gallons (6.1 million liters) of water, corn, and sugar (Figure 11). One of the primary objectives was to determine if short circuiting of the feed was occurring.

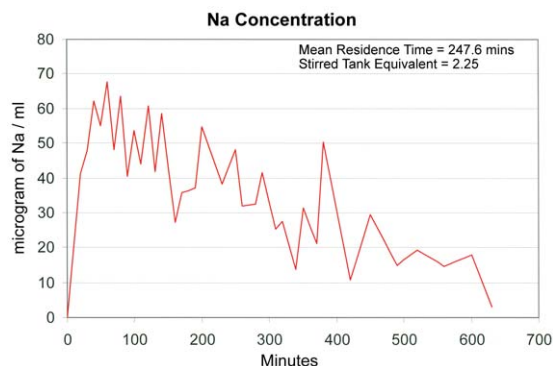
Figure 12 – The Method of Moments modelling for non-ideal flow was used for the calculation of the MRT and Stirred Tank Equivalent (STE).

Equivalent (STE). Figure 12 shows the test results. An STE of 2.25 indicated that complete mixing would not occur unless there were at least three tanks. Short circuiting of the raw feed through the vessel had also been a concern, however the study found no evidence to support this.
